HARTZELL PROPELLER INC.
SERVICE BULLETIN

HC-SB-61-269

Propeller - Hub Inspection

September 28, 2006

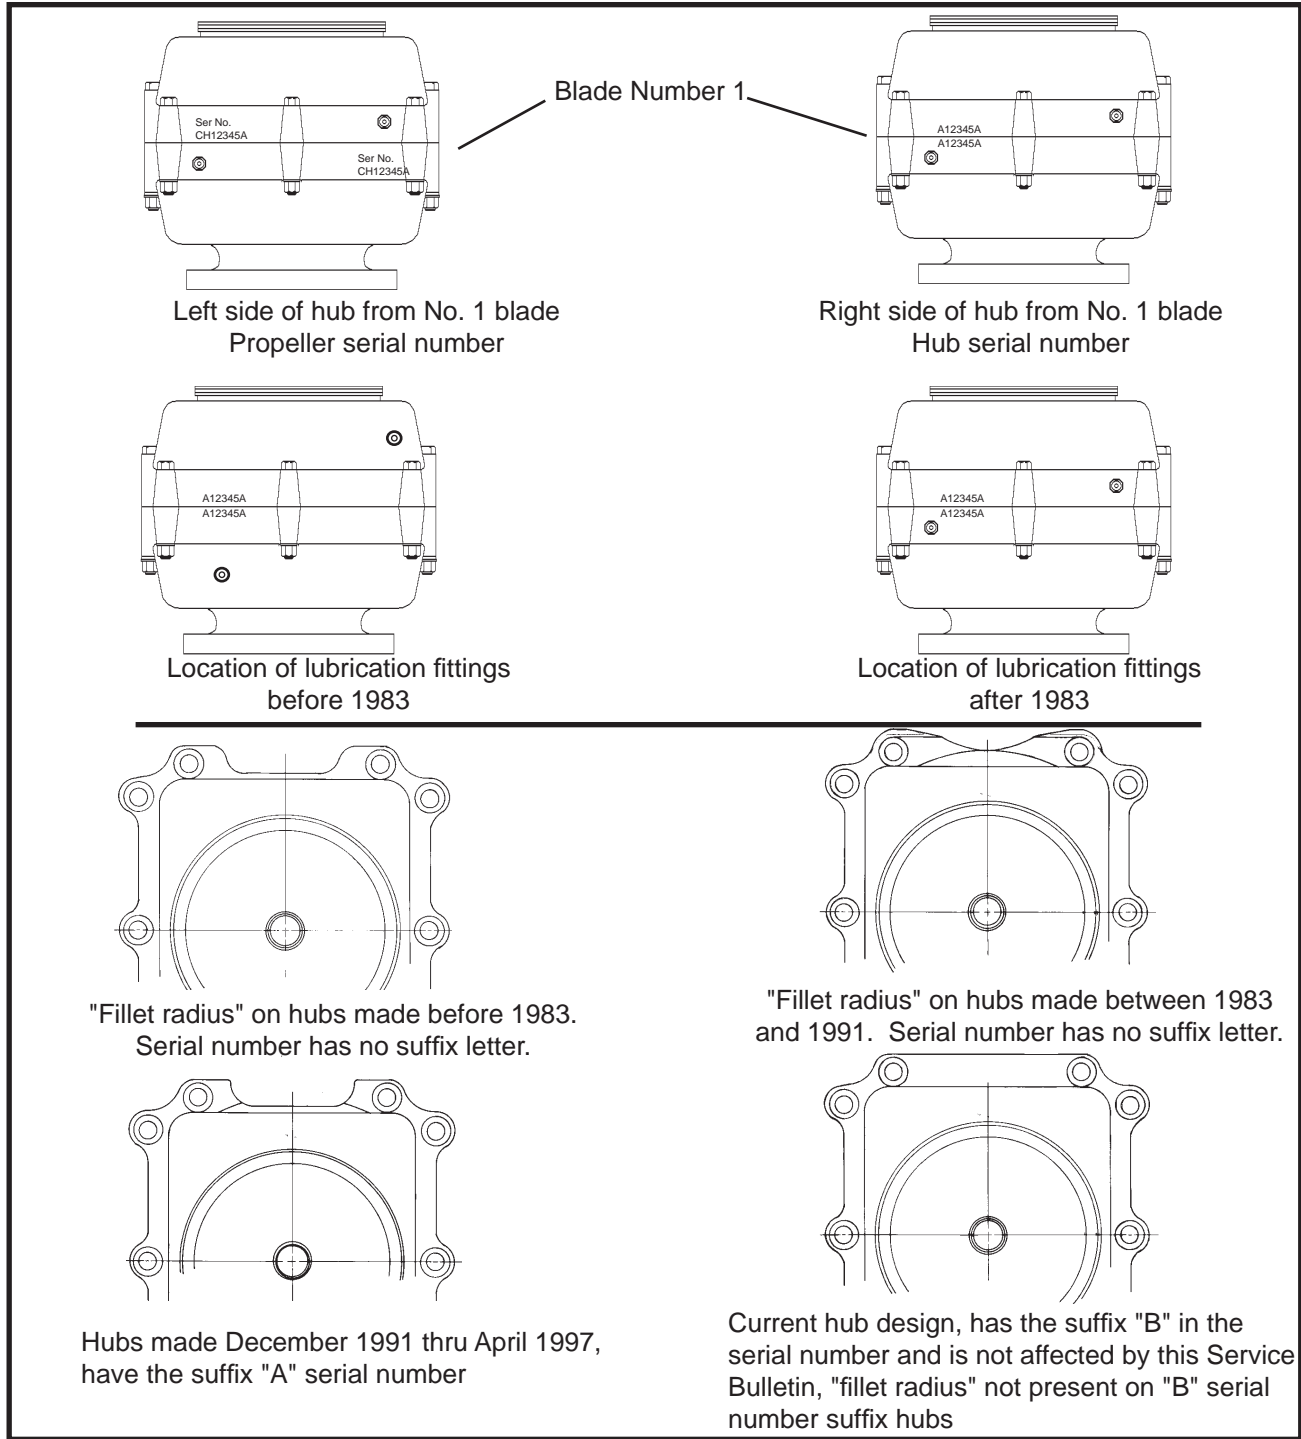
Hub Identification
Figure 2

NOTE 2: Hub and propeller serial numbers without suffix letter "A" or "B" were manufactured before 1991 and can be identified by two different styles of the fillet radius as shown in Figure 2. The "E" suffix letter is added to the hub with no suffix serial number to indicate that the initial eddy current inspection has been performed in accordance with this Service Bulletin and a repetitive eddy current inspection is required.

NOTE 2: A hub with a "B" suffix serial number is the current design. This design does not have a fillet radius. The fillet radius is the area of crack orientation. A hub with an "A" suffix serial number has a modified fillet radius. Installation of a "B" suffix hub is the recommended terminating action for this Service Bulletin.
